# GEORGIA DEPARTMENT OF TRANSPORTATION

## Waterway Report

**District:** 2  
**Bridge Inspector:** JW Matthews  
**Location ID:** 091-00574F-005.98N  
**Structure ID:** 091-0032-0

**Inspection Date:** 11/29/2011  
**Over:** SUGAR CREEK  
**County:** Dodge  
**Road Name:** MILAN-CHAUNCY ROAD

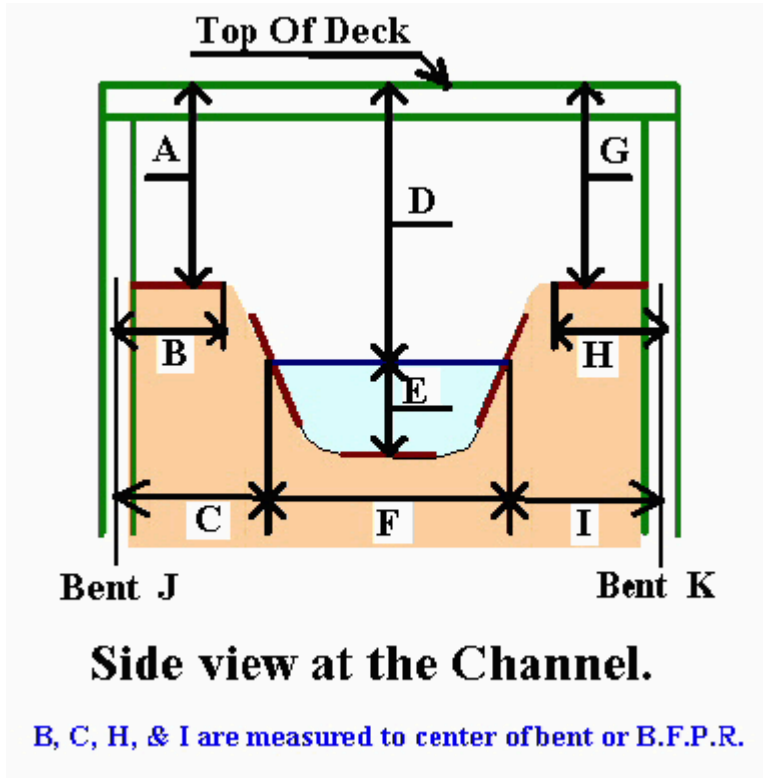
- A: 11
- B: 16
- C: 17
- D: 16.8
- E: 0.2
- F: 45
- G: 11
- H: 18
- I: 19
- J: 2
- K: 5

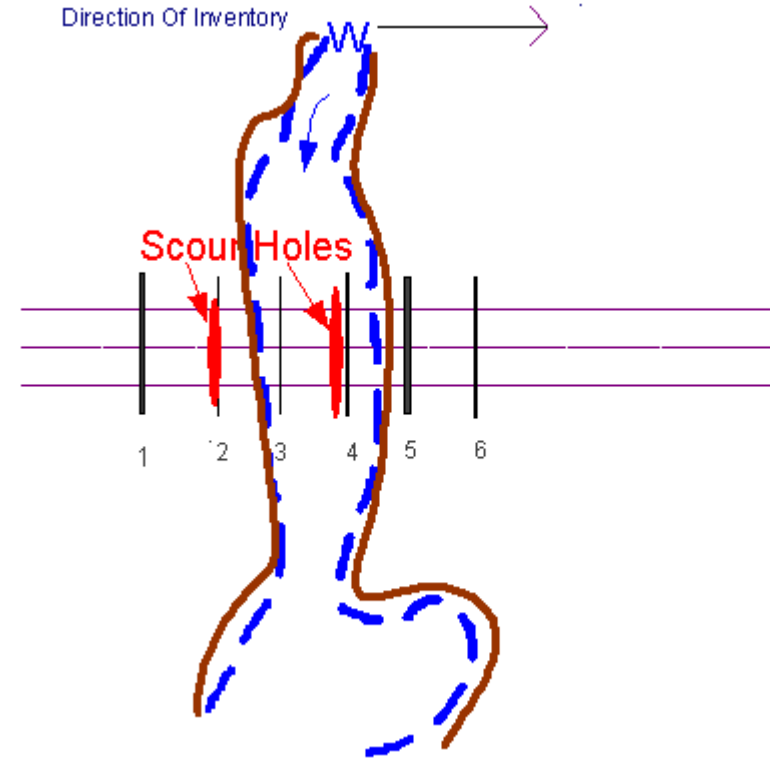
Location of Bridge Height 11' forward Bent 3

Scour Condition: 5      Waterway Adequacy: 6      Channel Protection: 7

Water high due to heavy rain 1/98.
