GEORGIA DEPARTMENT OF TRANSPORTATION

Waterway Report

District: 2
Bridge Inspector: Vince Tanner
Location ID: 181-00069X-001.42W
Structure ID: 181-5008-0

Inspection Date: 12/11/2012
Over: DOZIER BRANCH
County: Lincoln
Road Name: JONES MARTIN ROAD

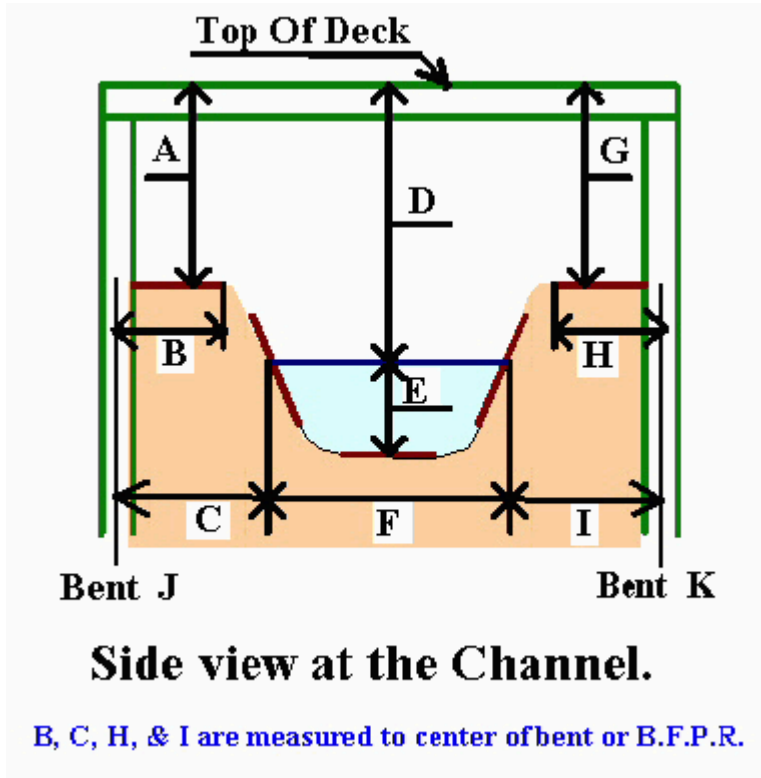
- A: 7
- B: 2
- C: 5
- D: 10
- E: 1.9
- F: 16
- G: 9
- H: 1
- I: 4
- J: 1
- K: 2

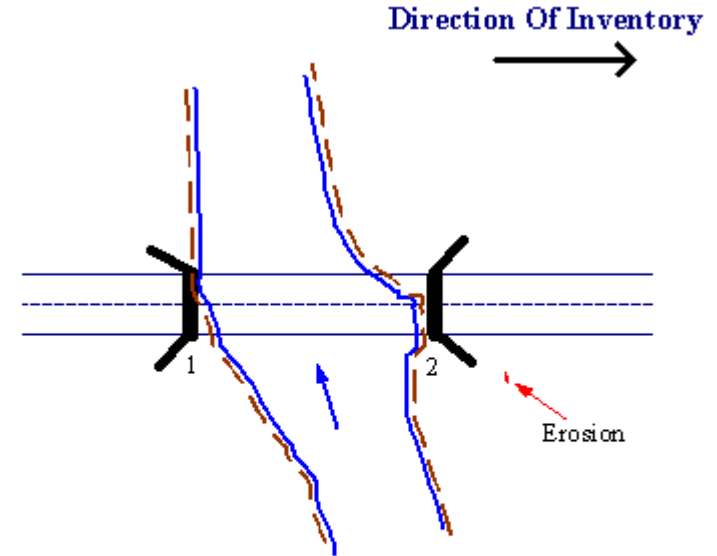
Location of Bridge Height 11' rear of abutment 2

Scour Condition: 7 Waterway Adequacy: 8 Channel Protection: 6
