Benteen Elementary Existing Conditions

Existing Conditions

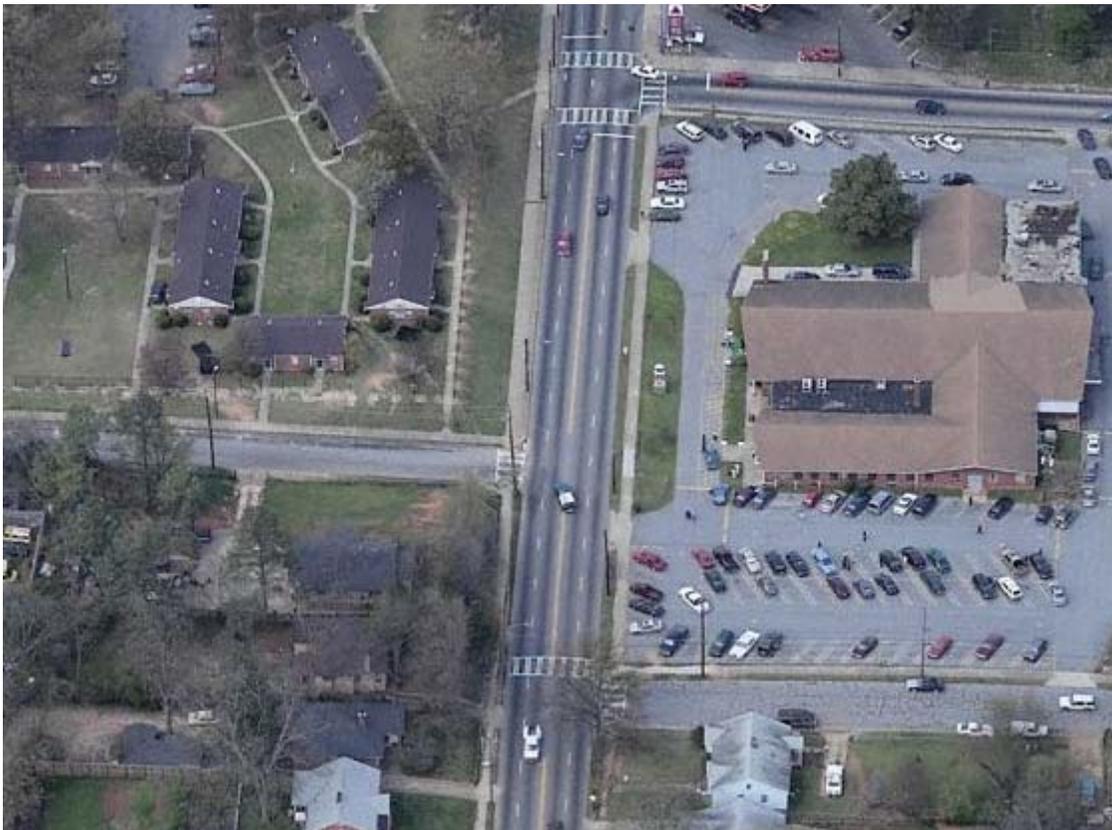
The uncontrolled crosswalk at Cassanova and Boulevard is extremely dangerous due to its lack of advance warning, and its low visibility marking. This is also an unsignalized intersection.

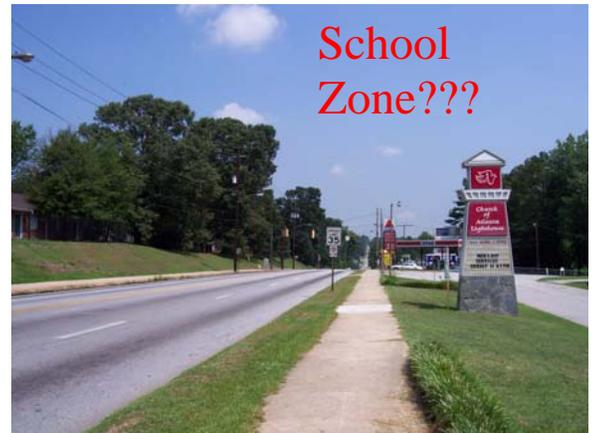
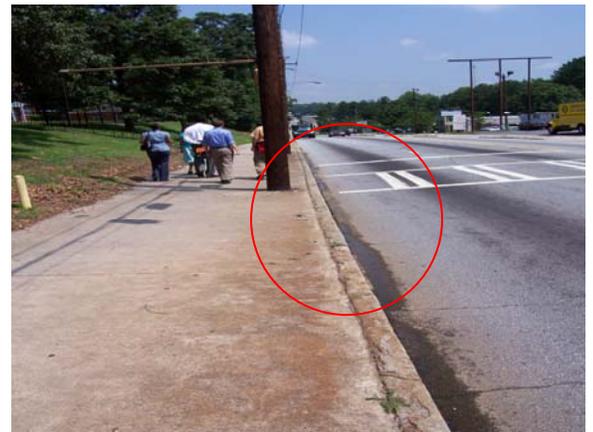
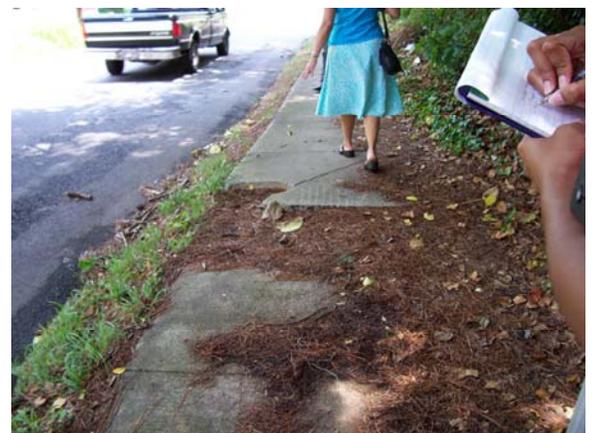
Custer Avenue, adjacent to the school, has a marked school zone, a MARTA stop (some students take this bus), and a crossing guard. The speed limit is 35 mph, and 25mph in the school zone (as designated by a 25 mph sign with flashing yellow beacon). However, the speed on Custer commonly reaches 35 to 40 mph even within the school zone. This two lane road carries a high volume of traffic, most of which is cut-through traffic. The sidewalk on Custer, most of which is in good condition, measures 3 ft. However, some of the sidewalk has gaping holes, a huge safety hazard to the kids. This is especially a problem on Custer along east end of the school.

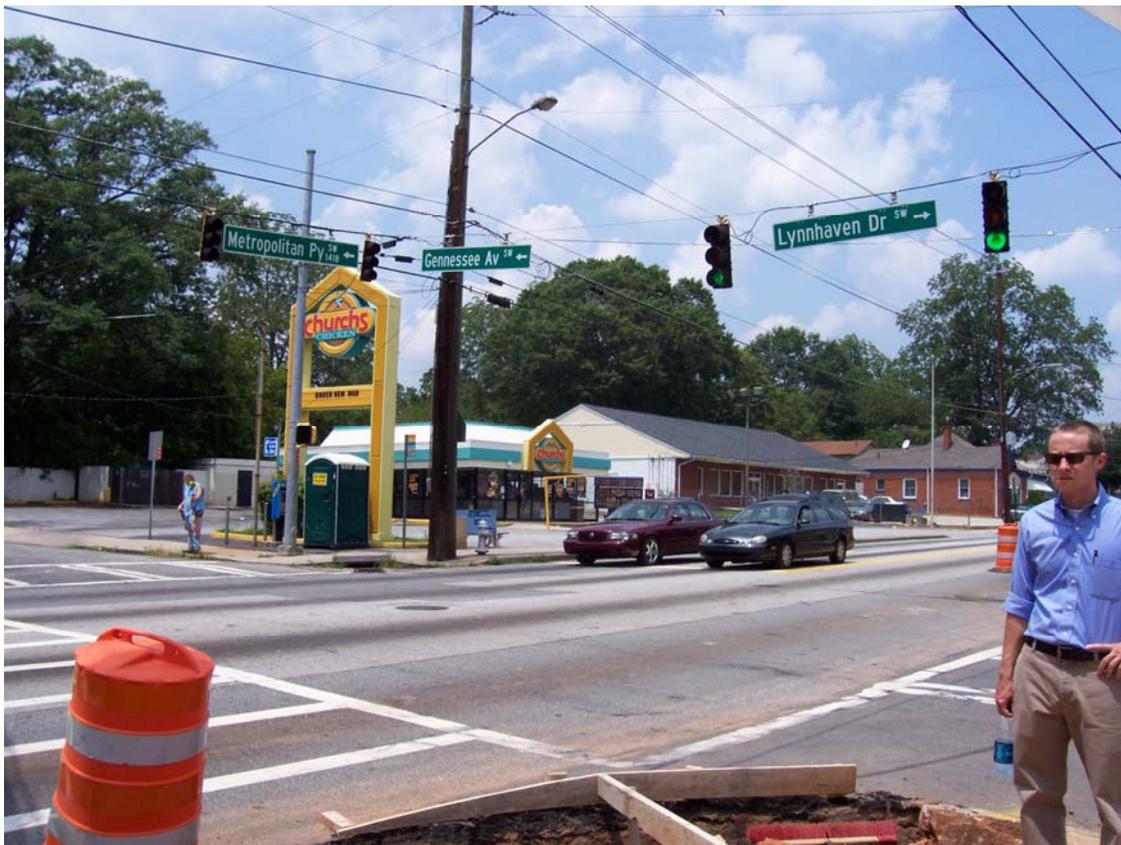
Observation of the crosswalk during dismissal showed a big problem with cars on Metropolitan running the red light. Cars are also turning right off Genessee Avenue onto Metropolitan, disregarding the crosswalk. Sidewalks exist on both sides of Metropolitan however the curbs are non existent in most places. The sidewalks have little or no buffer and with the curbs flush with the travel lanes, there is nothing to deflect speeding cars if they veer out of the lane and into pedestrians. Metropolitan Parkway is one of the 10 most dangerous roads for pedestrians in Georgia. In fact, the school's crossing guard had her arm broken last in the fall of 2006, as she pulled a child out of the path of a motor vehicle that was running a red light.
