GDOT ARCHAEOLOGICAL SHORT FORM FOR NEGATIVE FINDINGS

Phase I Archaeological Survey Addendum of the Walther Boulevard at SR 316 Grade Separation

GDOT Project No.: MSL-0003-001 (168) P.I. No.: PI 0010425

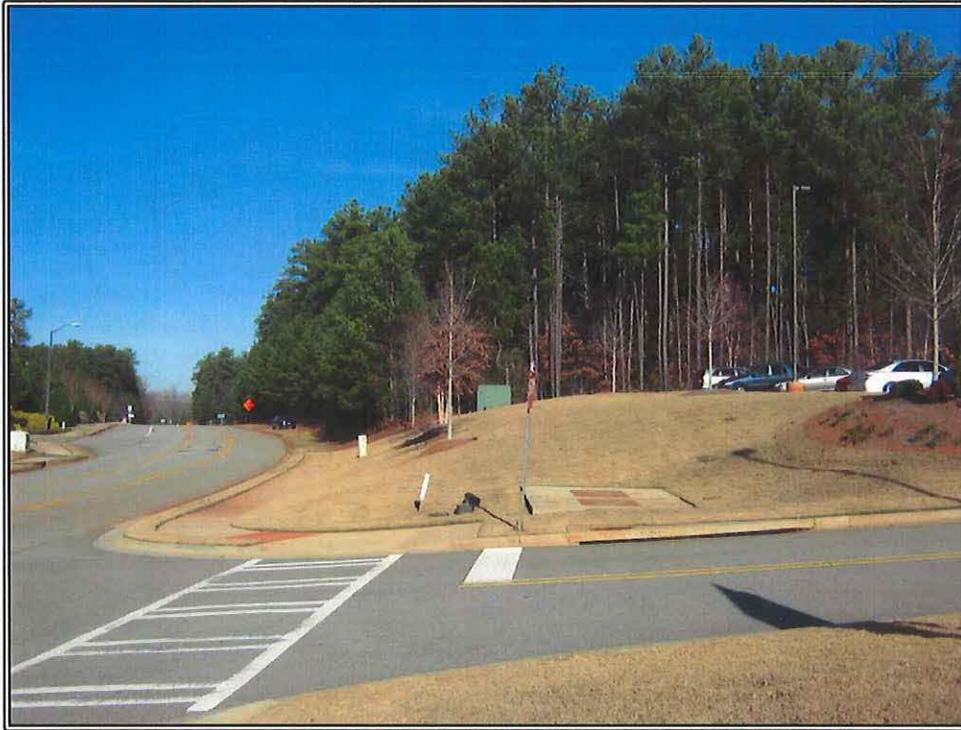
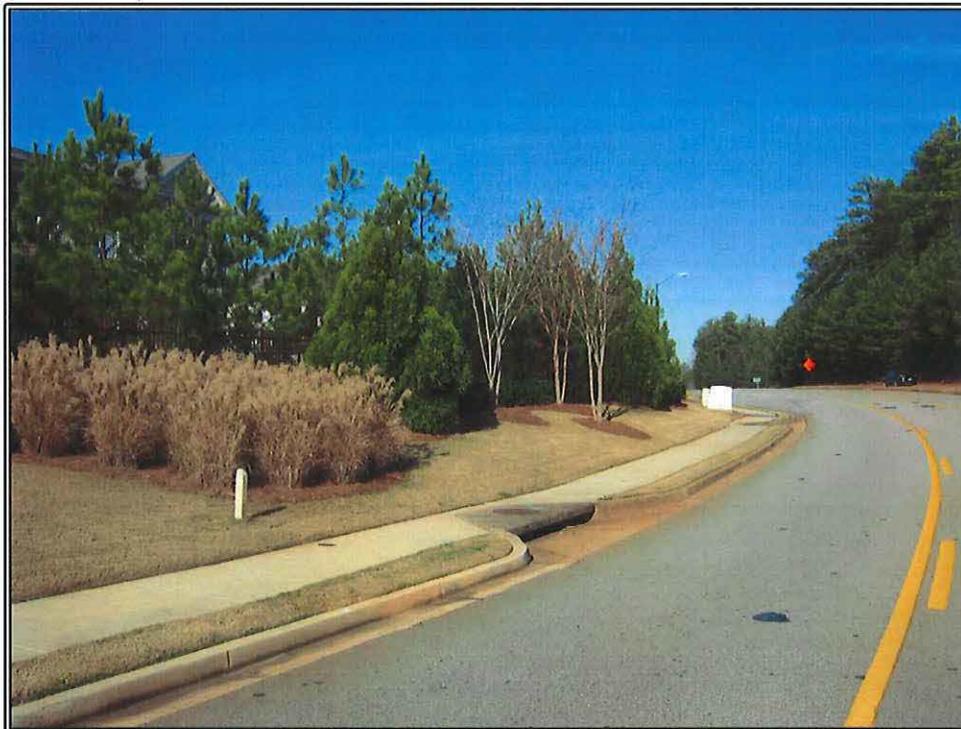
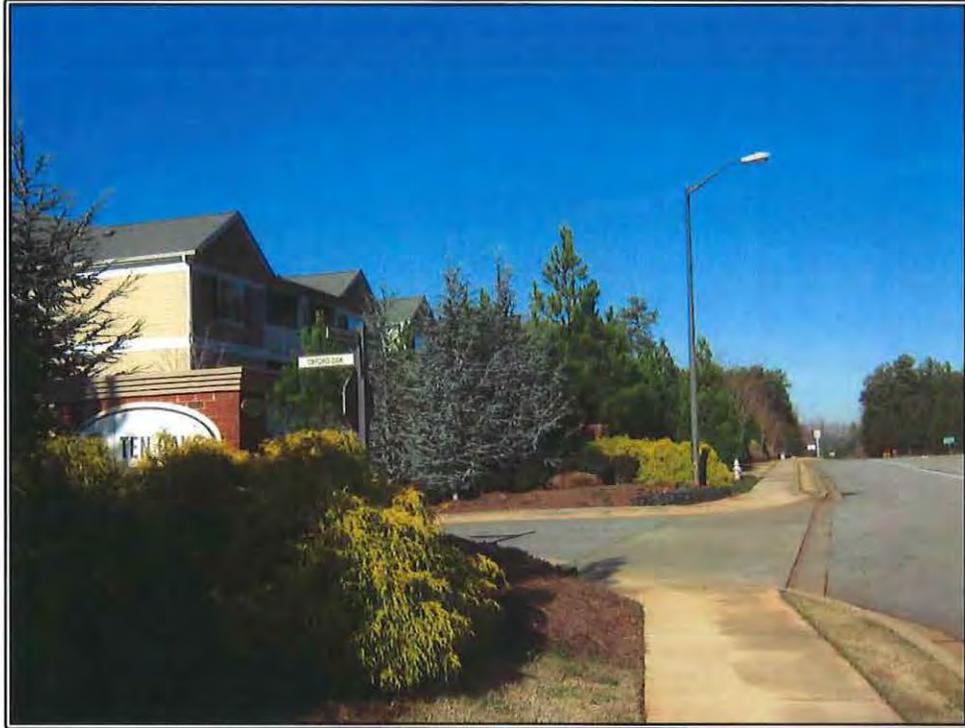
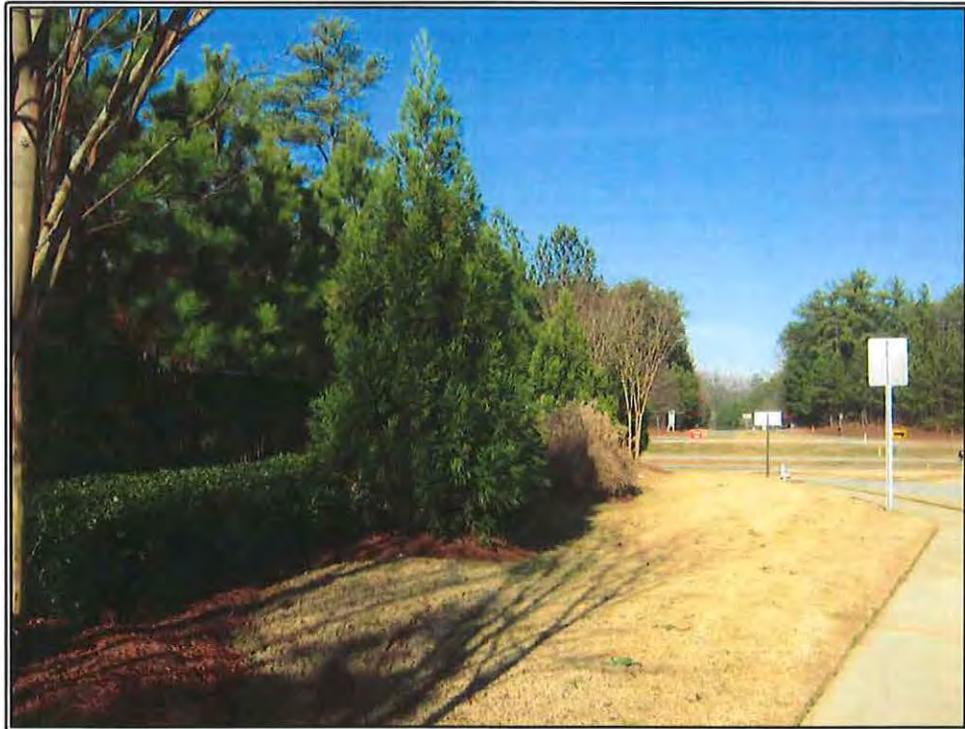
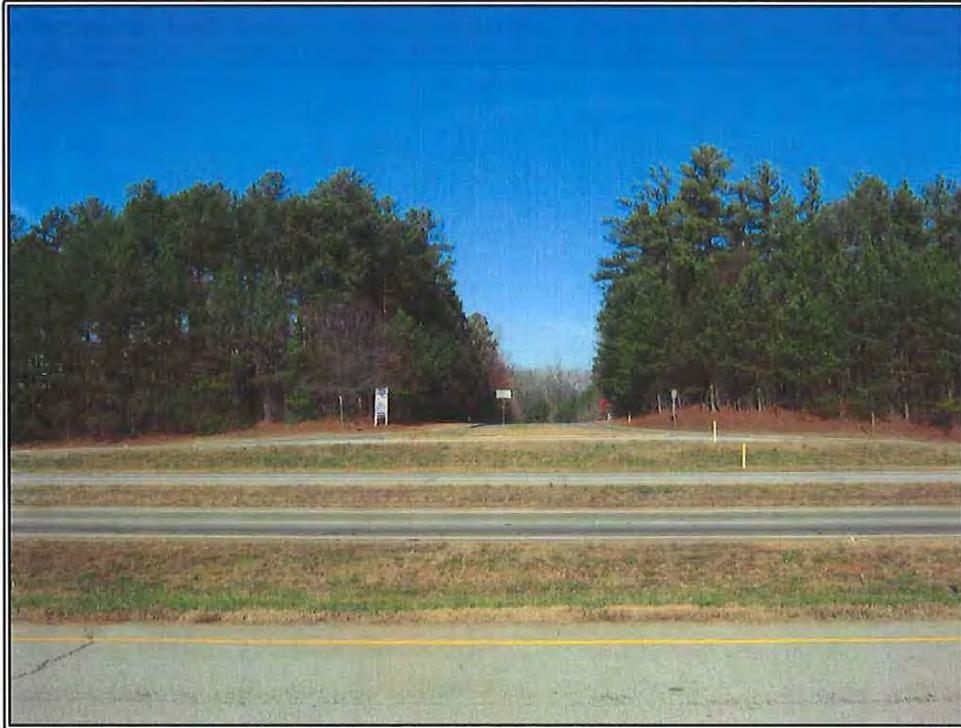
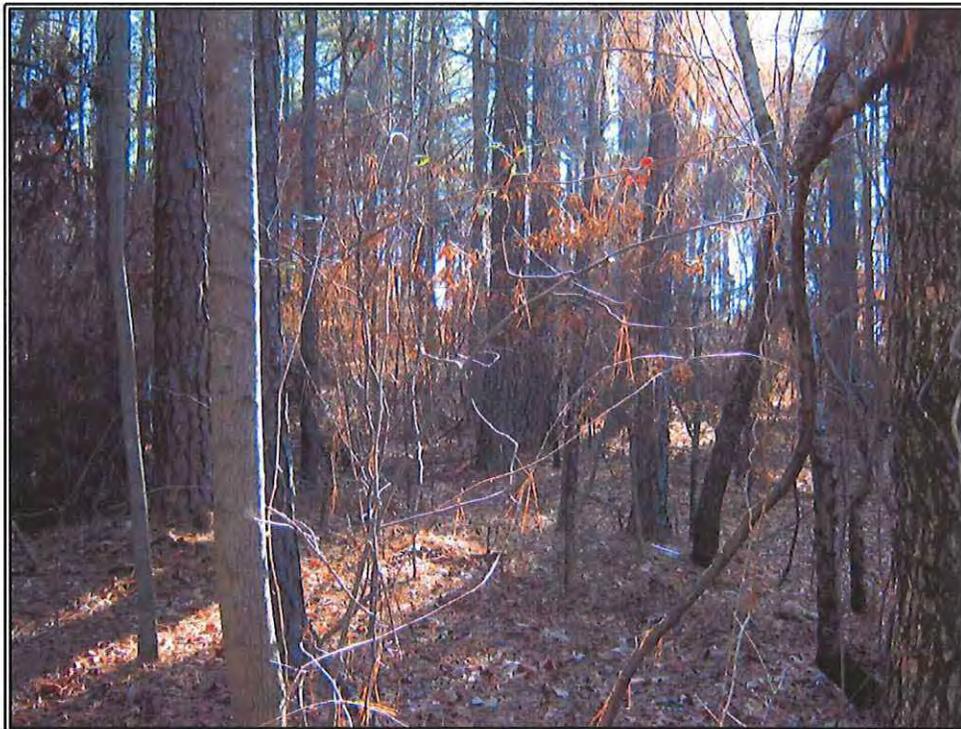
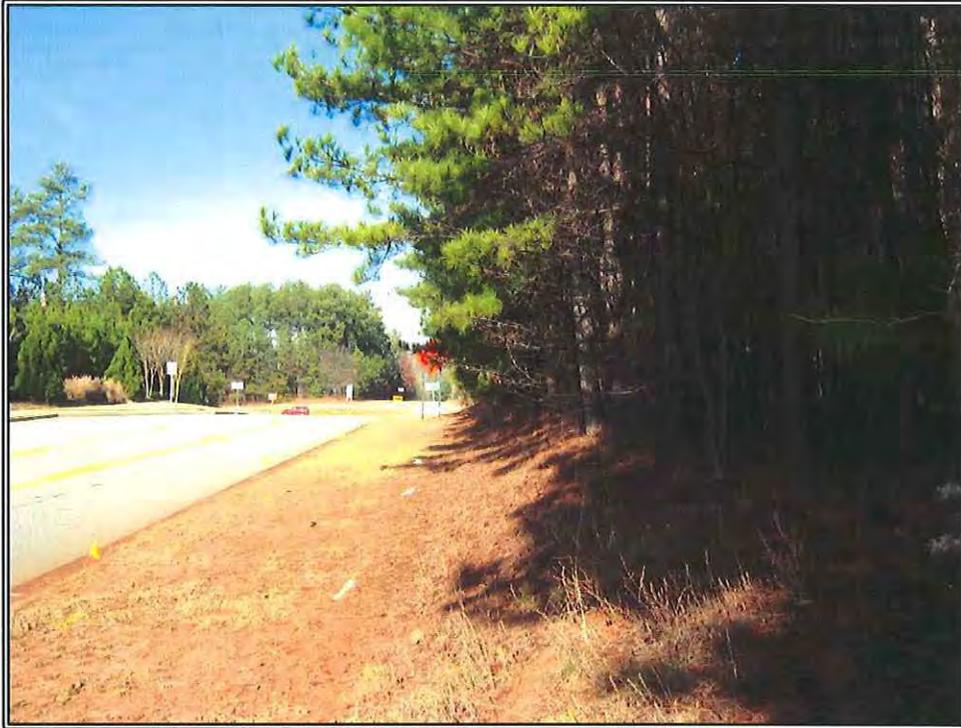
In the developed areas, the right-of-way along Walther Blvd, south of SR 316, consists of sidewalks, ditches, graded slopes, and earthen privacy berms. In many areas buried utilities are present. Within the ESC west of Walther Boulevard is an apartment complex. The only somewhat undisturbed area of the corridor and the ESC is the wooded tract at the southeast corner of SR 316 and Walther Boulevard (Photographs 1 through 7).

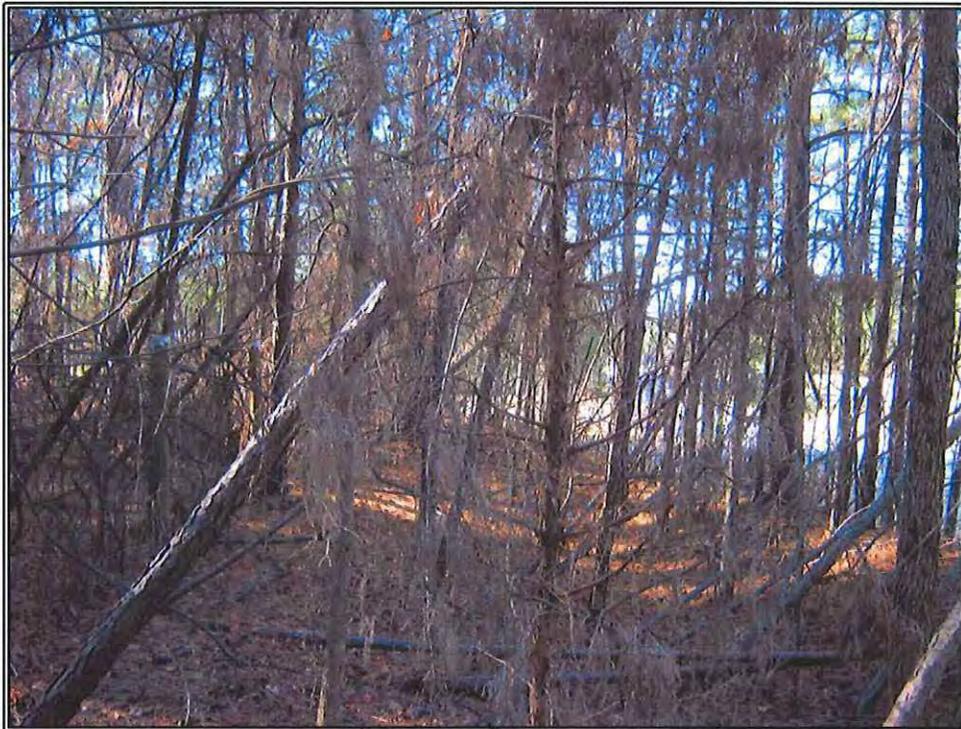
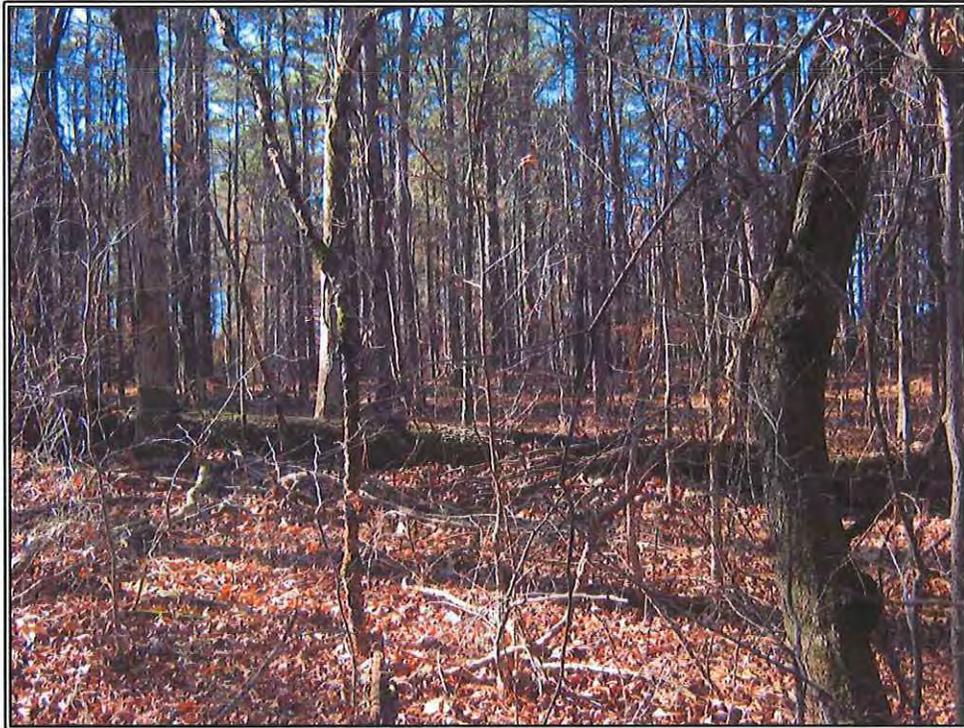
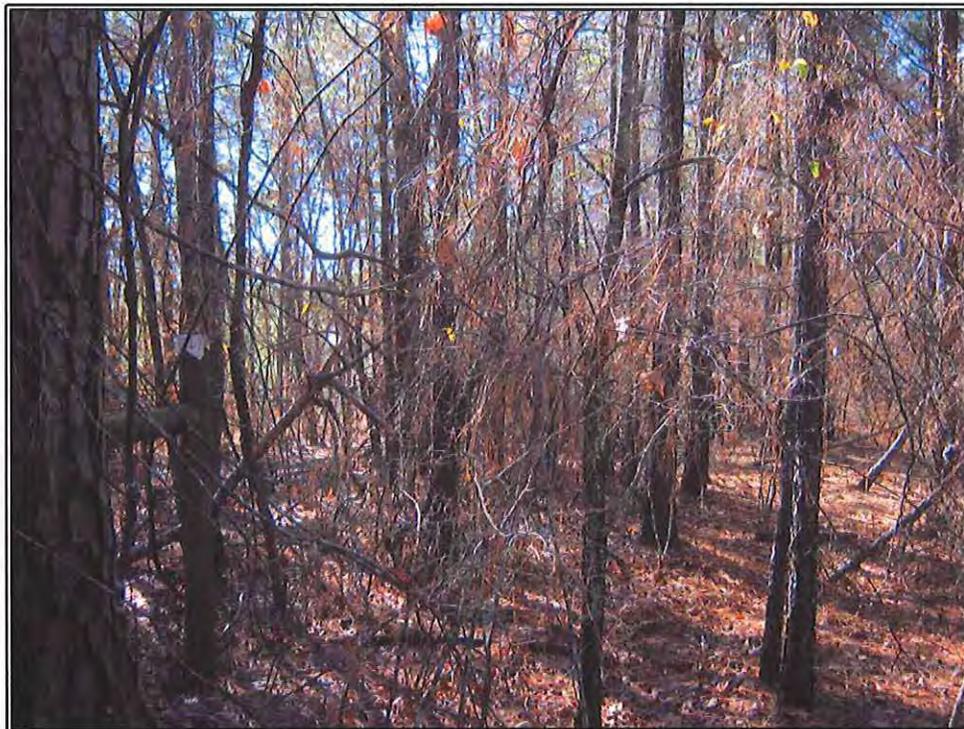
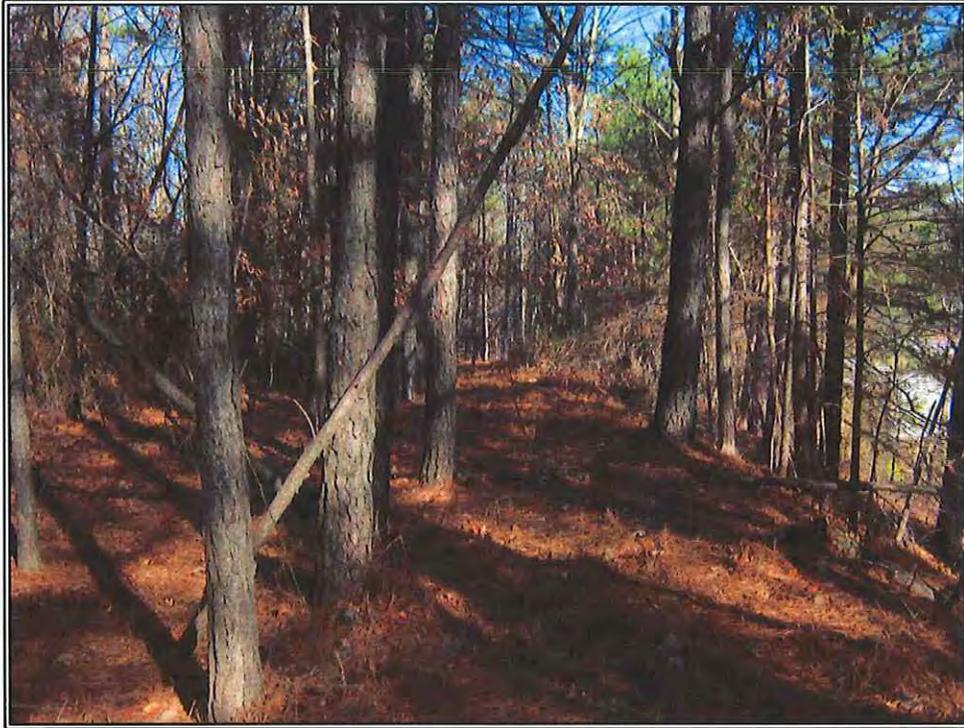
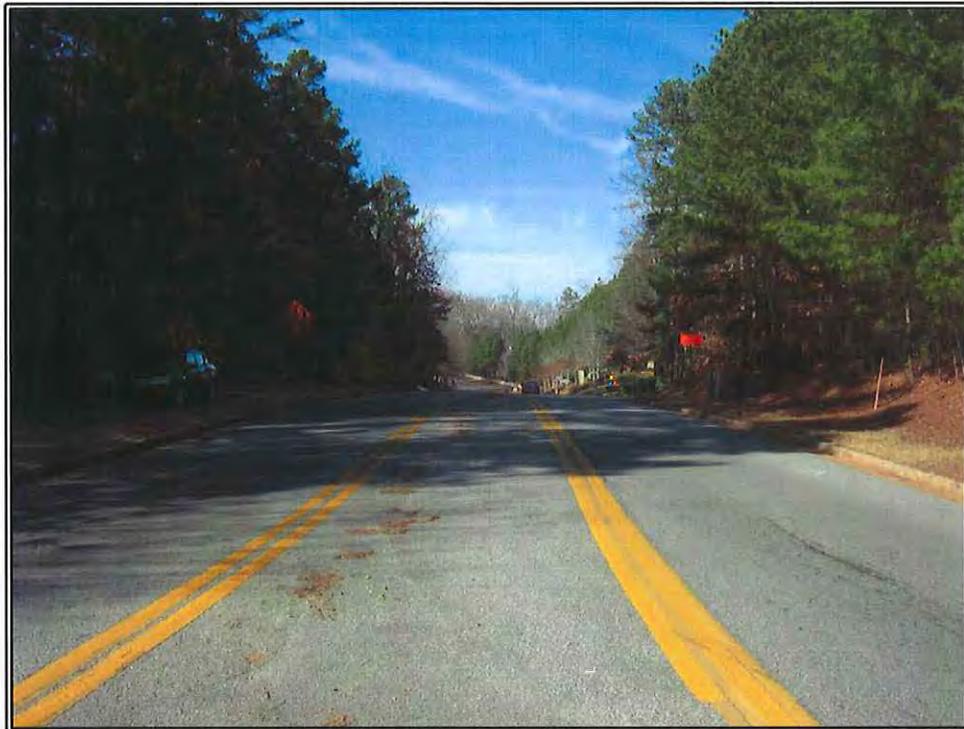
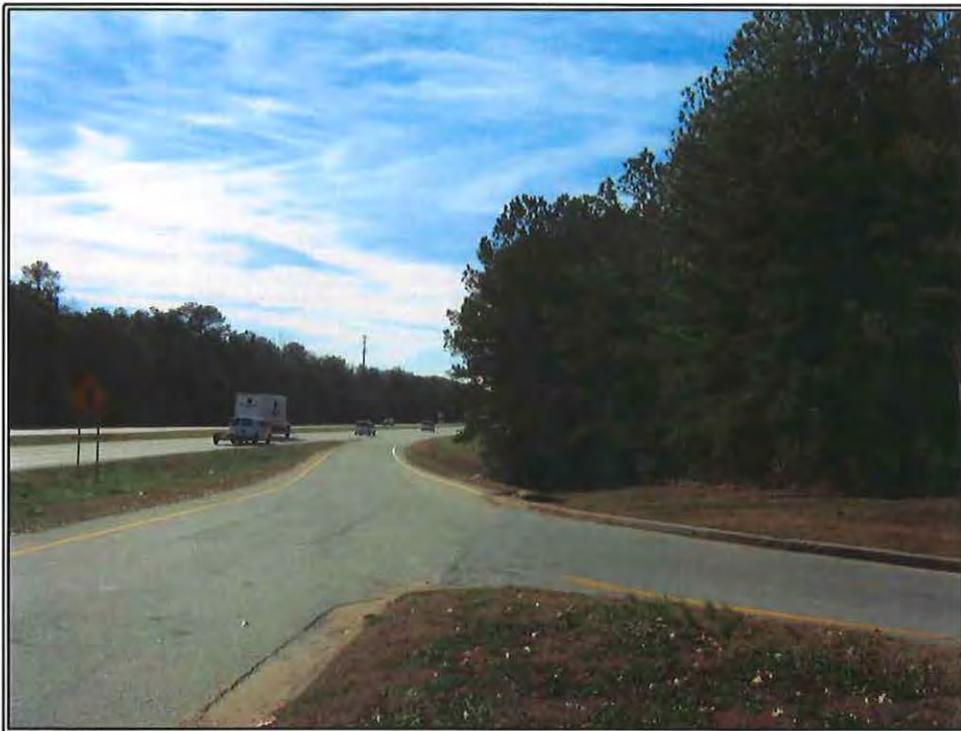
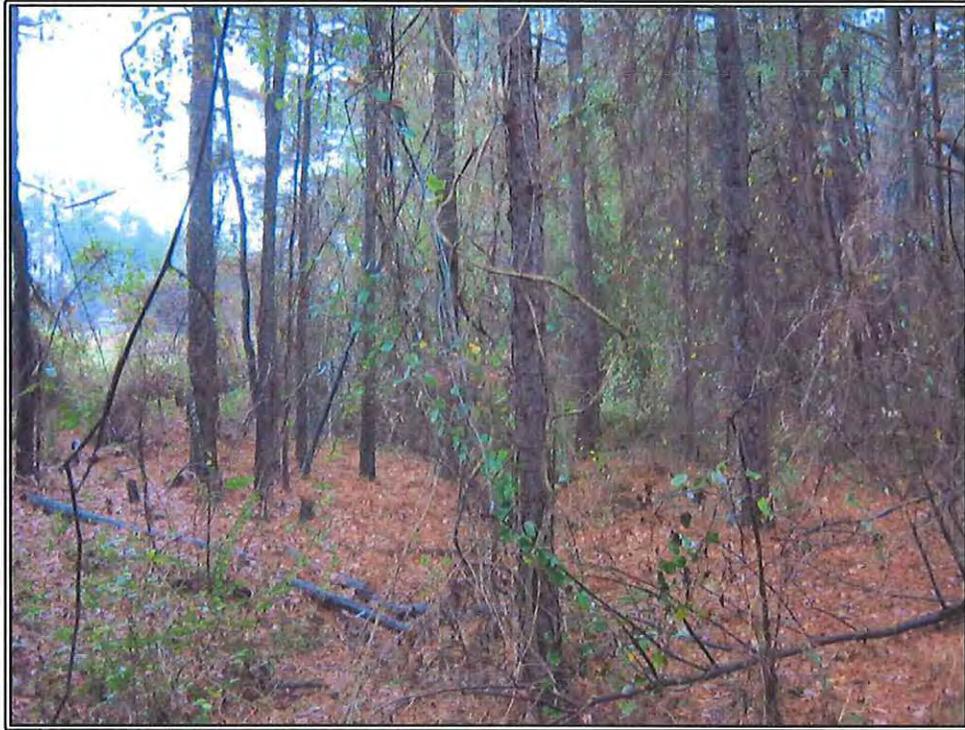
The right-of-way of SR 316 consists of heavily graded areas and graded slopes. The median of SR 316 consists of graded slopes and a ditch. Within the ESC are apartment complexes and wooded areas (Photographs 5 through 12, 16 and 17).

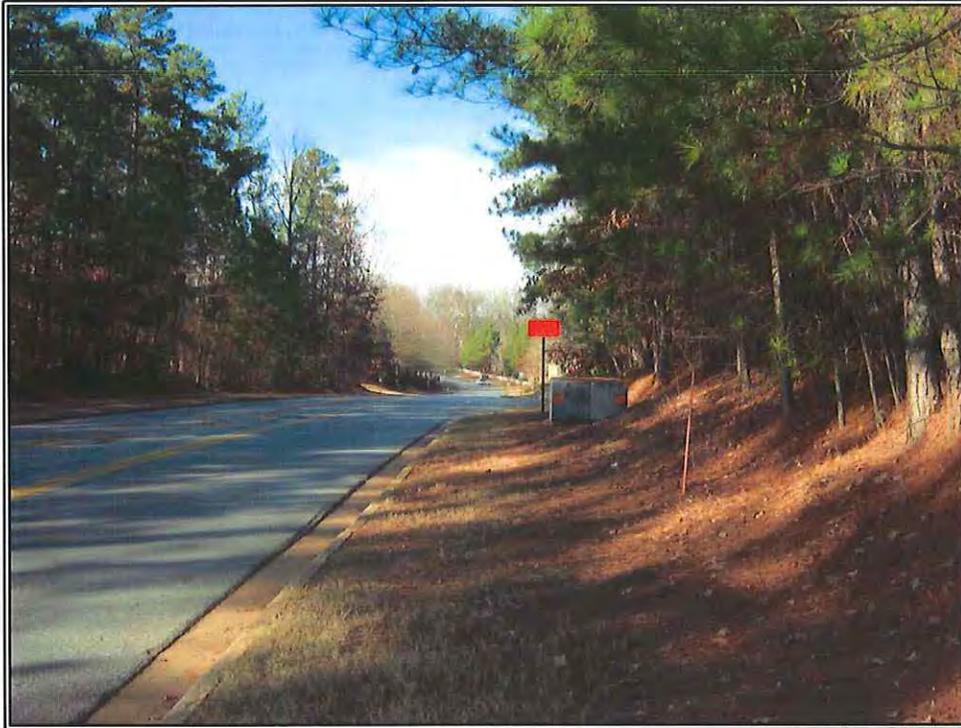
The project corridor along Walther Boulevard, north of SR 316, consists of sidewalks, ditches, graded slopes, and earthen privacy berms. Buried utilities are also present on both sides of the road. Within the ESC on both side of the road are apartment complexes (Photographs 12 through 14 and 18).

Photograph 13. View of the project corridor along the east side of Walther Boulevard, showing embankment cut and buried utilities, looking north.

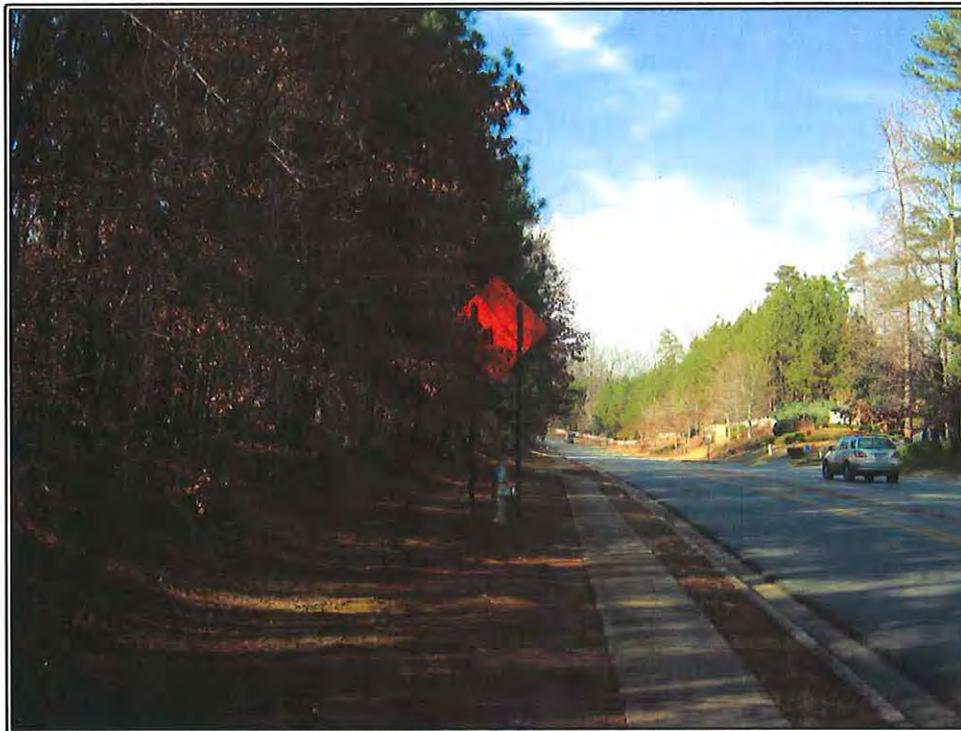
Photograph 14. View of the project corridor along the west side of Walther Boulevard, showing embankment cut and sidewalks, looking north.

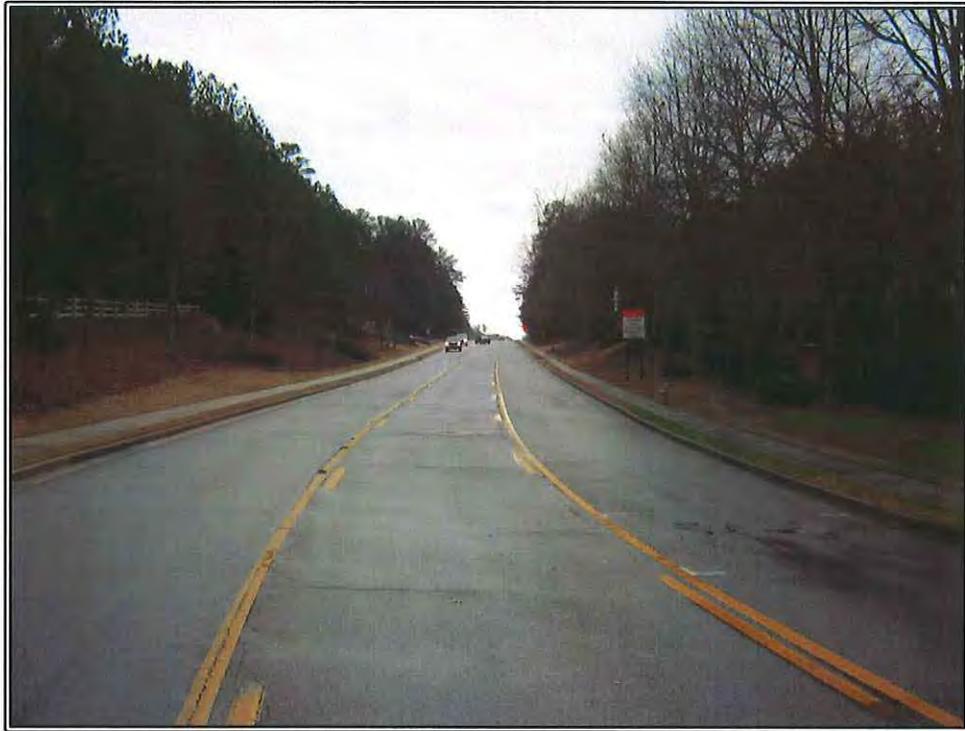
Photograph 18. View of the project corridor along Walther Boulevard, north of SR 316, looking south.
