ECOLOGY ASSESSMENT/DESCRIPTION OF JURISDICTIONAL  
WETLANDS, NON-WETLAND WATERS OF THE U.S., AND  
PROTECTED SPECIES SURVEY

**WIDENING AND RECONSTRUCTION OF US 441/SR 24  
GDOT PROJECT EDS-441(42)(43)  
P.I. 222560, 122660  
MORGAN AND OCONEE COUNTIES, GEORGIA**

ORIGINAL DATE SUBMITTED: May 24, 2006

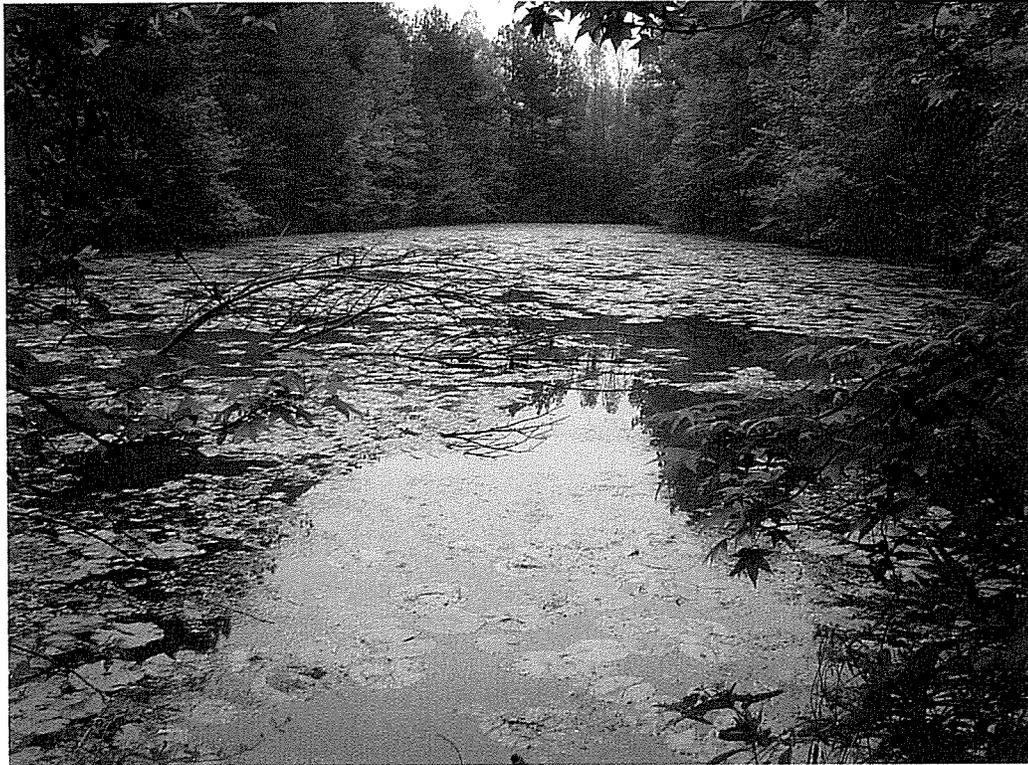
**Photo 1: Pond 21, new location alignment, west of existing US 441**

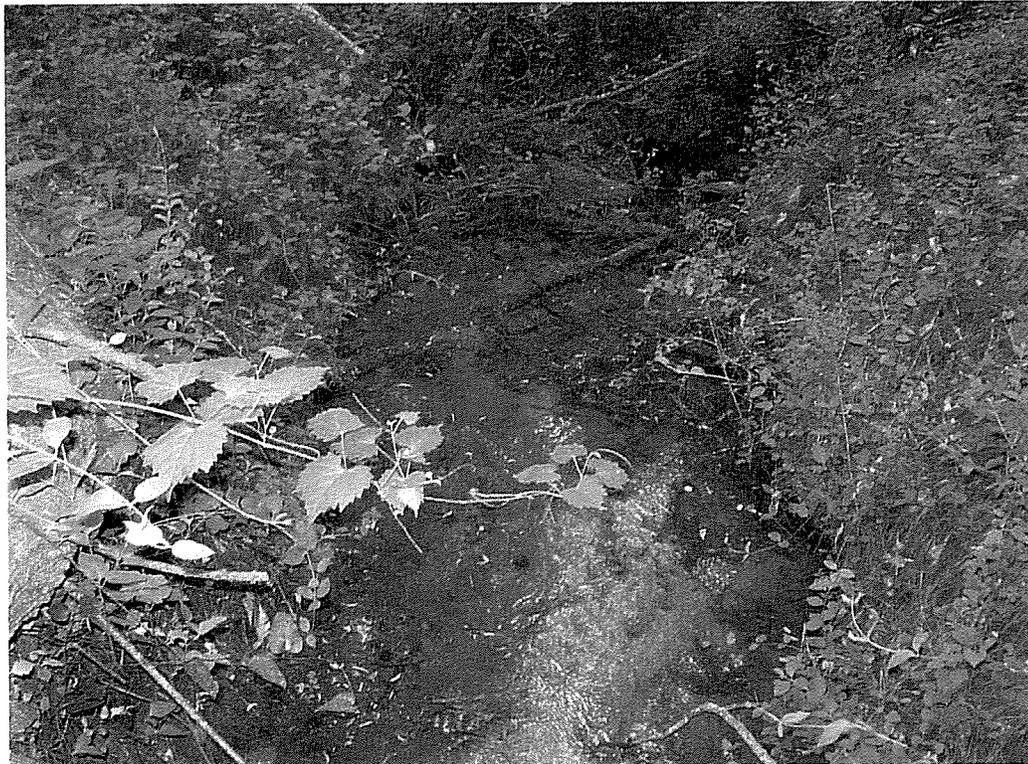
**Photo 2: Stream 22, view downstream, west of existing US 441**
