North Mitchell County Elementary School

Safe Routes to School Report

April 2015

Baconton, Georgia

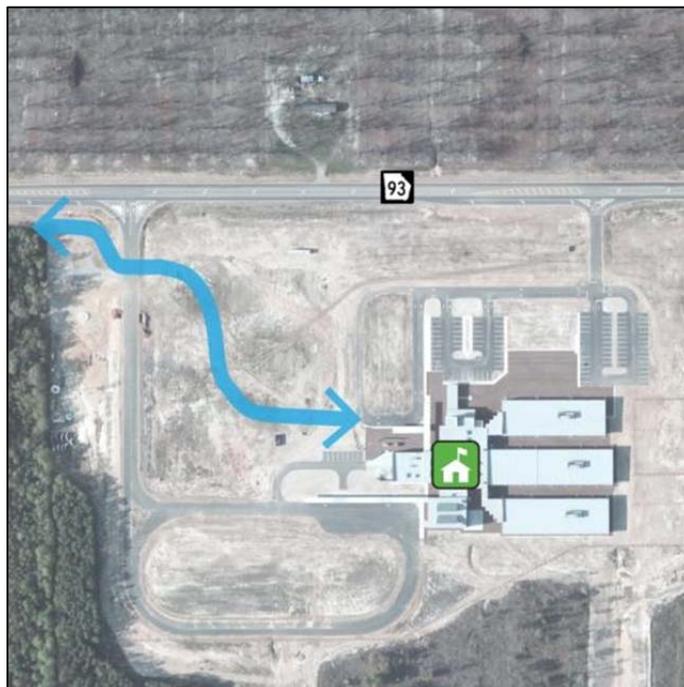
Figure 2. The pop-up location demonstrated how a shared use path would benefit walkers and bicyclists.

After assessing the internal sidewalk infrastructure, the team walked to the intersection of GA-93 and the bus driveway loop. This intersection was the location for the ‘Pop-Up’ installation improvement shown in Figure 2. The temporary ‘Pop-Up’ installation components included a shared use path, high-visibility crosswalk pavement markings, wayfinding and educational signage (Photos 6, 7 and 8). The shared use path components demonstrated to the team the effectiveness of basic changes that can increase safety while promoting walking and bicycling to school.

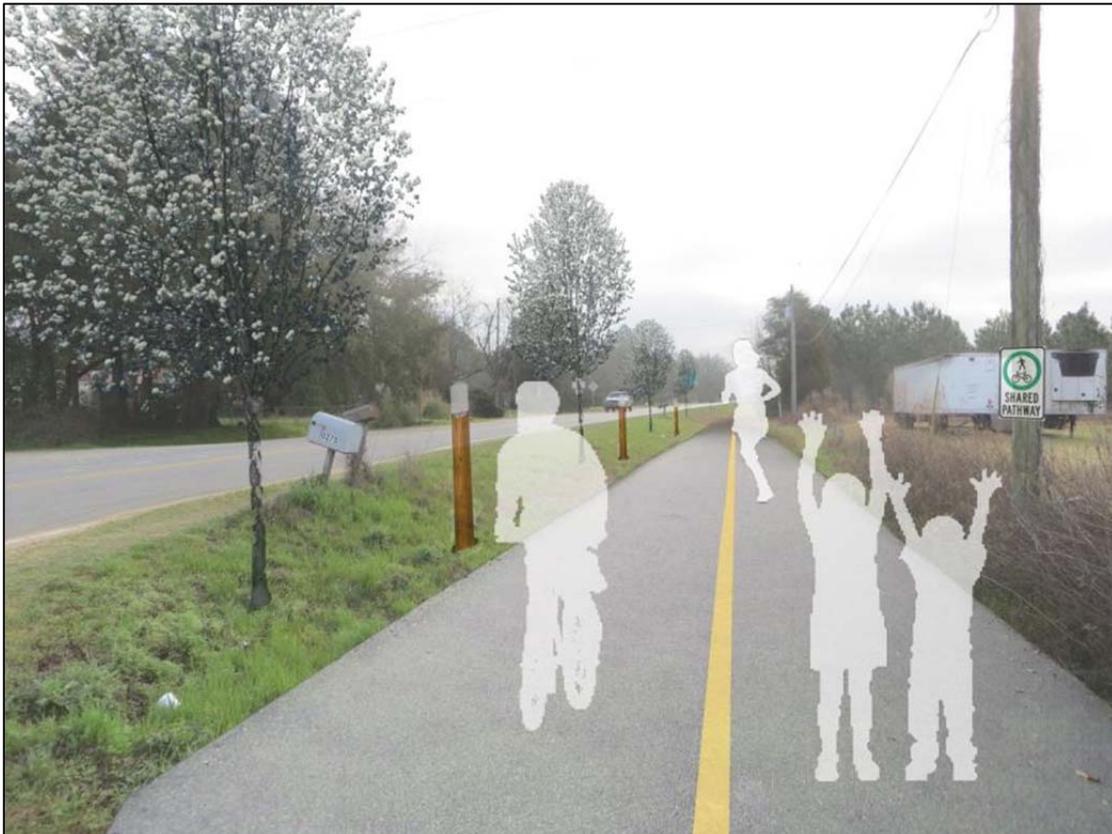
Figure 3: Proposed shared use path infrastructure recommendation on the south side of GA-93.

- **Shared Use Path.** Construct a shared use path on the south side of GA-93 from at least the intersection of US Route-19/GA-93/Lester Road NE to NMCES campus. The shared use path would include sufficient lighting, high-visibility crosswalk pavement markings and the *Manual on Uniform Traffic Control Devices* (MUTCD) 'Combination Bike and Pedestrian Crossing' (W11-15 with W11-15p) signage at driveway or roadway intersections. Shared use paths are a valuable element of comprehensive pedestrian and bicycling networks. As low-stress facilities, these pathways offer a preferred alternative on which pedestrians and bicyclists do not have to compete for space with motor vehicles. The paths and trails should also include adequate lighting for year-round use.

- **Signage and Wayfinding.** Team up with students, faculty and community members to install wayfinding markings and signage for the entire length of the proposed shared use path. The signage and wayfinding components will help increase awareness and establish branding within the community to harness support building momentum for future use.

- **Shared Use Path Features.** Long term use of the shared use path facility should anticipate an increasing demand of varying users. As the growth increases, the community should look to expand shared use path connections and wayside features that may include; bicycle parking, seating, shade structures, water fountains and or landscape enhancements.

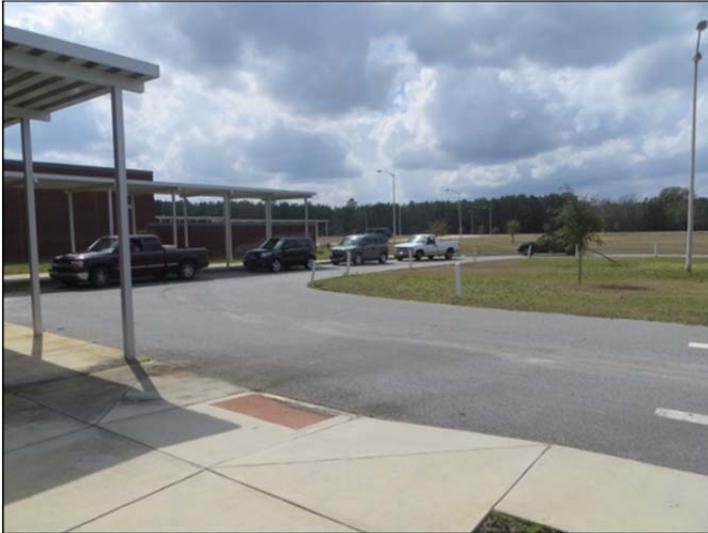
Photo 1: The only ADA compliant curb ramp in the parent drop-off loop.

The SRTS Team met at NMCES to discuss possible walking and bicycling infrastructure improvements for the community. The team focused their efforts on access to and travel on the campus. The group first surveyed the elementary school’s internal parking lot and sidewalk infrastructure (Photo 1). For the most part, the parking facilities have curb separated sidewalks, but very few ADA-compliant curb ramps or high-visibility crosswalk pavement markings.

- **Crosswalk markings and ramps.** Retrofit all ends of existing crosswalks to be ADA-compliant and restripe all existing crosswalks with high-visibility white crosswalk pavement markings. Crosswalks and ADA-compliant ramps are an important component of creating a connected pedestrian network. Existing crosswalk markings in the internal parking lot at NMCES are not high-visibility white pavement markings and many connections to the crosswalks are not ADA-compliant.
- **Pedestrian scale lighting.** Current campus lighting provides general lighting for the personal vehicle driveway loop, bus driveway loop and parking lot areas. The NMCES campus currently lacks pedestrian scale lighting and should be considered at intersections or corridors that may be perceived as a barrier for safe walking and bicycling to the school campus.

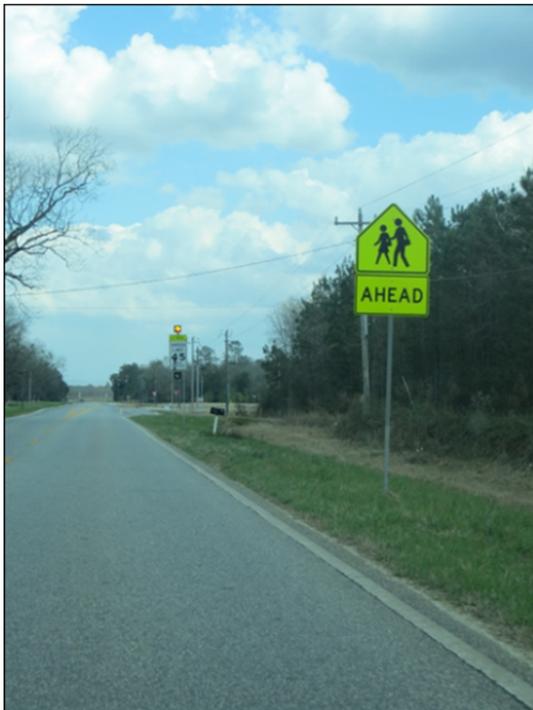
Photo 2: School zone and advanced school zone warning signage on GA-93.

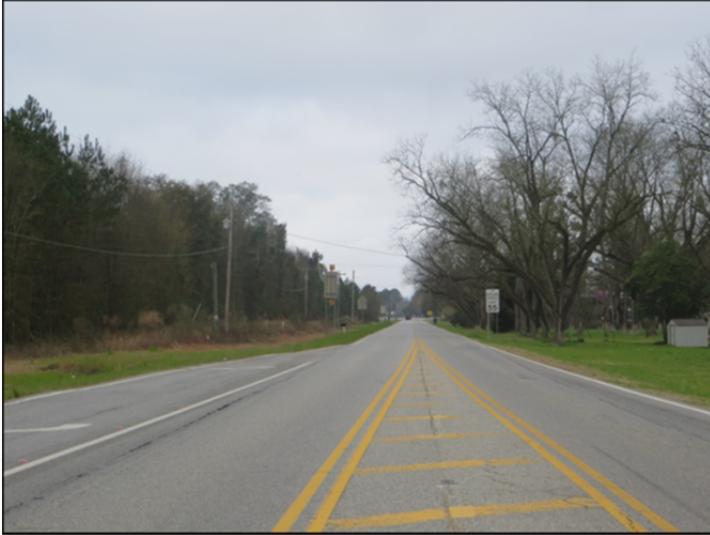
Photo 3: GA-93 in front of NMCES looking west towards the intersection of US Route-19 and City of Baconton.

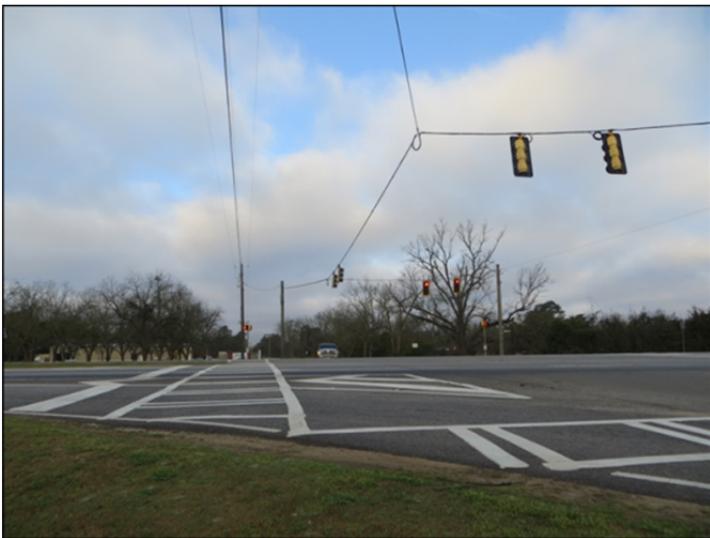
US Route-19 is located on the eastern edge of Baconton and provides north-south travel. It is classified as a principal arterial with an approximate 9,610 annual average daily traffic volume³. The typical roadway cross section is a four lane divided highway, approximately 30 feet wide on each side of the grass median with two 12 foot travel lanes and shoulders varying in width from 2 feet to 4 feet. The intersection of US Route-19 and GA-93 is signal controlled with pedestrian countdowns, has high-visibility crosswalk pavement markings crossing all four road segments, however lacks sidewalk infrastructure (Photo 4 and 5).

Photo 4: High-visibility crosswalk pavement markings at the intersection of US Route-19 and GA-93.

- **Sidewalks.** Construct sidewalk segments and ADA-compliant ramps to all four intersection crossings. Sidewalks along GA-93 should connect to the shared use path.

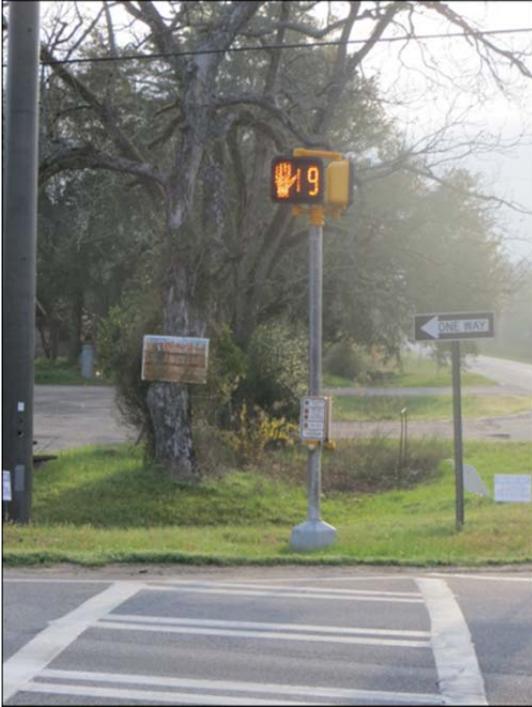
Photo 5: Typical pedestrian countdown signal at US Route-19 and GA-93 intersection with high-visibility crosswalk pavement markings. The intersection lacks accessible sidewalks to access the push buttons to activate the pedestrian countdown signal.

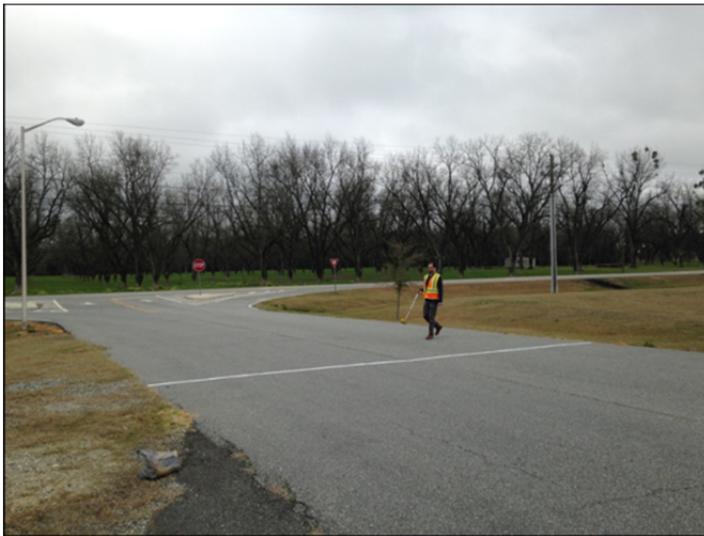
Photo 6: Temporary 'Pop-up' installation of a high-visibility crosswalk improvement for the shared use path concept (before).

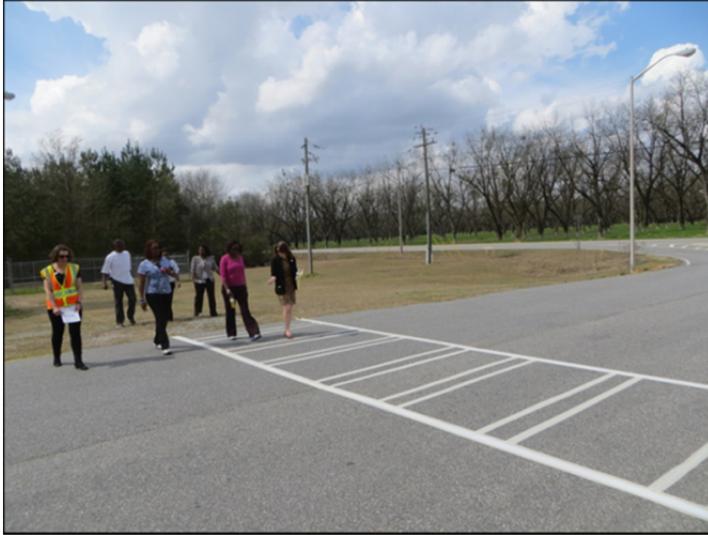
Photo 7: Temporary 'Pop-up' installation of a high-visibility crosswalk improvement for the shared use path concept (after).

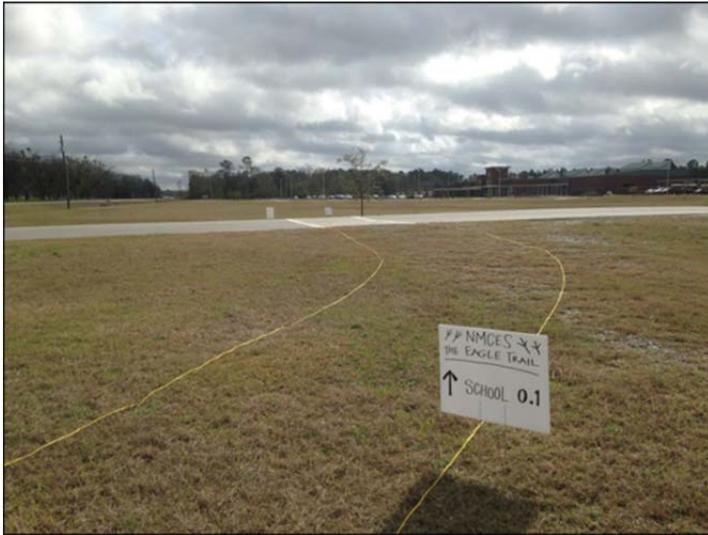
Photo 8: Temporary 'Pop-up' installation of wayfinding signage improvement for the shared use path concept (after).
