TABLE 17 APPROXIMATE PE PIPE LOCATION RELATIVE TO STEEL ANCHOR PIPE [1]

GEORGIA
DEPARTMENT OF TRANSPORTATION
OPERATIONS DIVISION-OFFICE OF MAINTENANCE

KEEPER RING & WASHER RETROFIT 4 OF 5
TALMADGE MEMORIAL BRIDGE RETROFIT
CHATHAM COUNTY CSNHS-M002-00 (373)

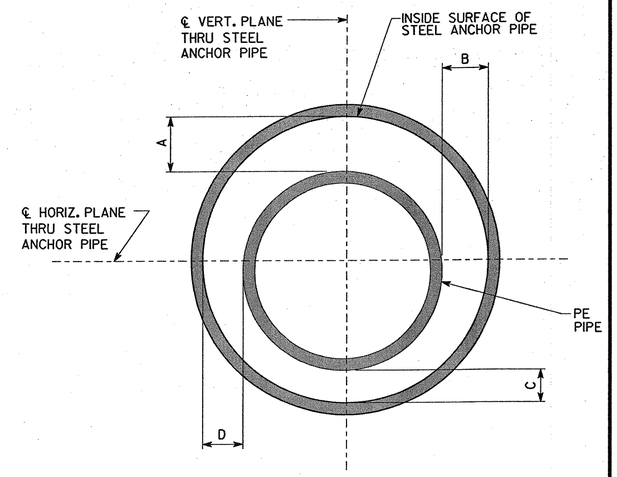
CROSS SECTION AT END OF STEEL ANCHOR PIPE

(SHOWN WITHOUT STEEL KEEPER RING OR WASHER)

1. THE APPROXIMATE DIMENSIONS PROVIDED IN TABLE 17 ARE FOR REFERENCE ONLY. THESE DIMENSIONS SHALL NOT BE USED FOR FABRICATION OF WASHERS. ALL DIMENSIONS MUST BE FIELD MEASURED BY THE CONTRACTOR FOR FABRICATION OF WASHERS. SEE GENERAL NOTES ON SHEET NO. 10.
2. THE DIMENSIONS IN TABLE 17 WERE TAKEN AT THE END OF THE STEEL ANCHOR PIPE WITH A TOLERANCE OF ±1/8" AND DO NOT GIVE THE DIMENSIONS FOR WASHERS.
3. SINCE THE DIMENSIONS VARY ALONG THE CABLE STAY, THE CONTRACTOR SHOULD NOTE THAT THE MEASUREMENTS FOR FABRICATION OF WASHERS SHOULD BE TAKEN AT 1 1/2 INCH (FOR THE EXPOSED FACE OF WASHER) AND 7 1/2 INCHES (FOR THE HIDDEN FACE OF WASHER) FROM THE END OF THE STEEL ANCHOR PIPE.
4. N/A - DIMENSIONS NOT AVAILABLE.
5. AT REPAIR ② LOCATIONS THE WASHER MEASUREMENTS SHALL BE TAKEN AFTER COMPLETION OF REPAIR ②.
