STATE	PROJECT NUMBER	SHEET NO.	TOTAL SHEETS
GEORGIA	CSNHS-M002-00 (373)	15	26

GEORGIA
DEPARTMENT OF TRANSPORTATION
OPERATIONS DIVISION-OFFICE OF MAINTENANCE

KEEPER RING & WASHER RETROFIT 5 OF 5
TALMADGE MEMORIAL BRIDGE RETROFIT
CHATHAM COUNTY CSNHS-M002-00 (373)

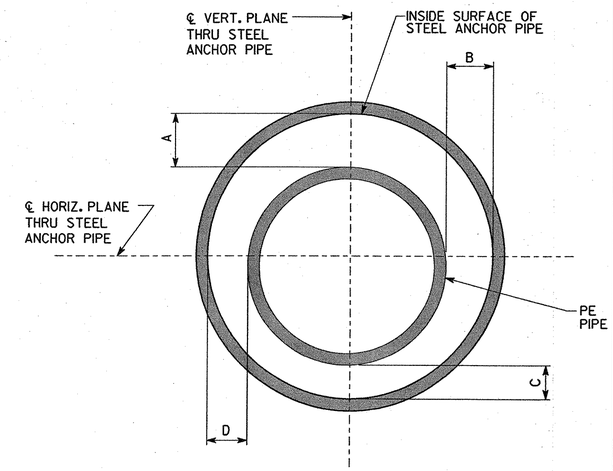
CROSS SECTION AT END OF STEEL ANCHOR PIPE
(SHOWN WITHOUT STEEL KEEPER RING OR WASHER)

TABLE 18 APPROXIMATE PE PIPE LOCATION RELATIVE TO STEEL ANCHOR PIPE (1)

(1) THE MEASUREMENTS AND WASHER CONDITIONS ARE AS PER THE 2001 FIELD INSPECTION, AND THE CURRENT MEASUREMENTS AND WASHER CONDITIONS MAY BE DIFFERENT THAN AS SHOWN ON THIS TABLE.
