Benteen Elementary Existing Conditions

Existing Conditions

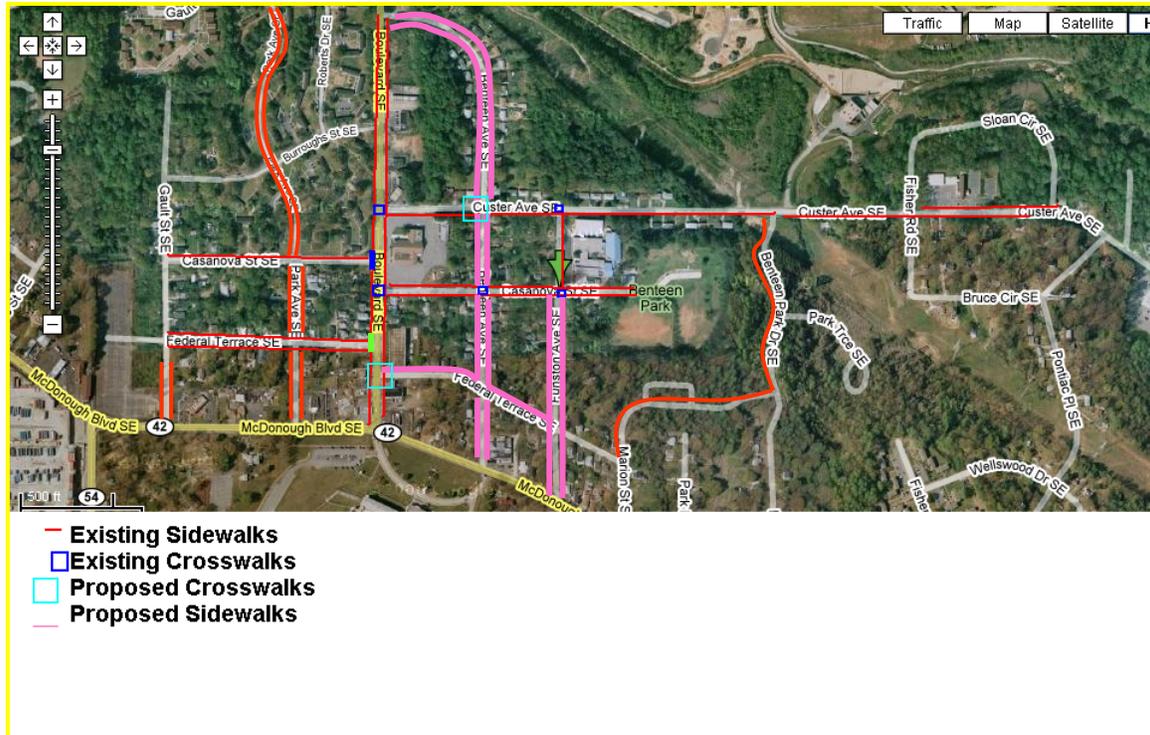
Kids at Benteen Elementary access three main roads on their route to school: Boulevard, Custer, and Benteen Way. Many of the walkers reside in the housing project across Boulevard, forcing most of them to cross this dangerous road. Once the kids cross Boulevard, they access either Custer or Cassanova Rd. to get to school. Several kids also walk from the east end of Boulevard, many of which are catching the Marta transit and exiting at Benteen Way.

Benteen Elementary is surrounded by neighborhood streets, most of which lack sidewalks and lane striping. Custer Avenue, Cassanova Road, and Boulevard Street are the exceptions. Custer and Cassanova connect the school to the neighborhood and have sidewalks on one side of the street. However, there is a 10 ft. disconnect in the sidewalk on Cassanova in front of the school. Boulevard functions as a major thoroughfare and has sidewalks on both sides. It should be noted that Boulevard still lacks other pedestrian amenities such as curb cuts, marked crosswalks, and pavement markings.

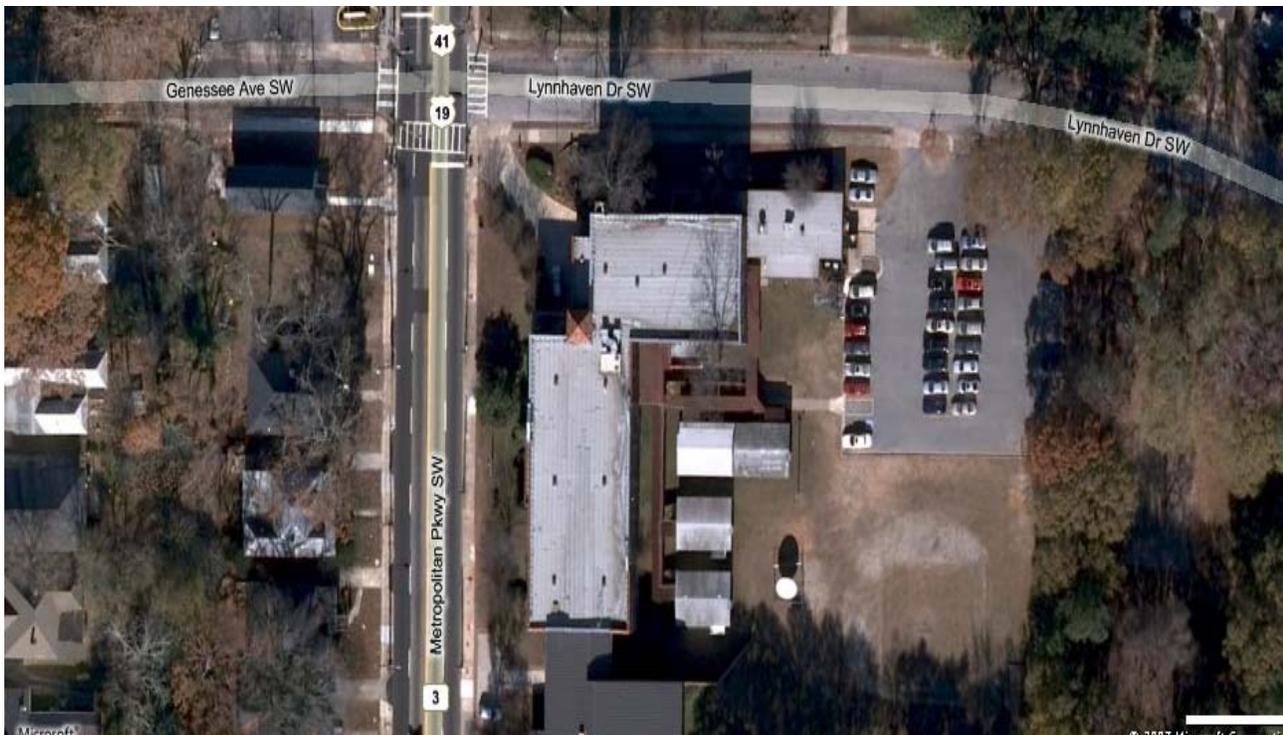
Metropolitan Pkwy is a 4 lane road with a speed limit of 35 mph. The speed limit is reduced to 25 mph during the school zone. However, because Metropolitan parallels Interstate 75/85, it carries a large volume of through traffic at high speeds. The school zone is fairly well identified with flashing beacon lights and pedestrian crossing signs. However, drivers need to be made aware of the school site long before they approach the flashing beacons. The main crosswalk, which is a 4-legged crosswalk used by students

crossing Metropolitan, is high visibility, signalized, and has pedestrian heads with push buttons. It is also staffed by a crossing guard for take-in and dismissal. There are no sight restrictions for vehicles in any direction. Sidewalks exist on both sides of Metropolitan Pkwy. The sidewalk directly in front of the school measures 6 ft. in width. The sidewalk located on the opposite side of Metropolitan Pkwy measures 4 ft. in width.

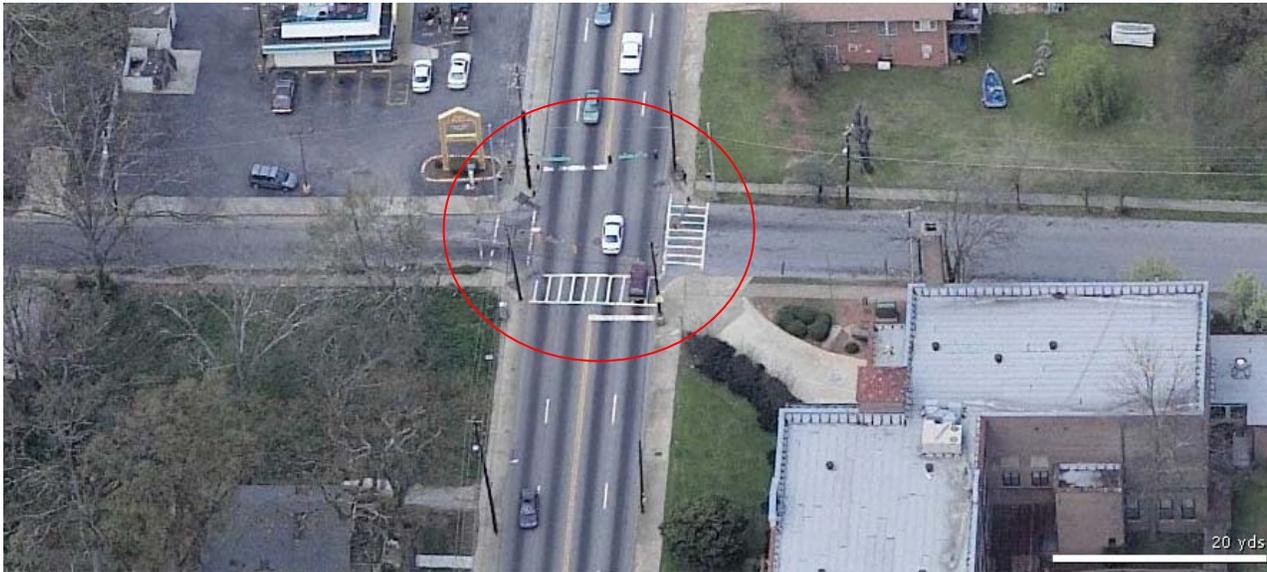
Capitol View Elementary sits on the corner of Lynnhaven Dr., which is the route that most kids who reside in the neighborhood behind the school take to school. Lynnhaven Dr. is a two-way road that measures 32 ft. wide. Despite the 25 mph speed limit, vehicles have been recorded traveling up to 35 mph. The Sidewalk exists on both sides of Lynnhaven Rd. for only 1 ½ blocks. The sidewalk leads to the school's side entrance where a sign is posted to draw attention to pedestrians.
