# GEORGIA DEPARTMENT OF TRANSPORTATION

## SubStructure Report

District: 4  
 Bridge Inspector: Benny Lomineck  
 Location ID: 275-00011X-000.62E  
 Structure ID: 275-5003-0

Inspection Date: 1/4/2011  
 Over: MCKEEVER SLOUGH CRK  
 County: Thomas  
 Road Name: REICHERTVILLE RD

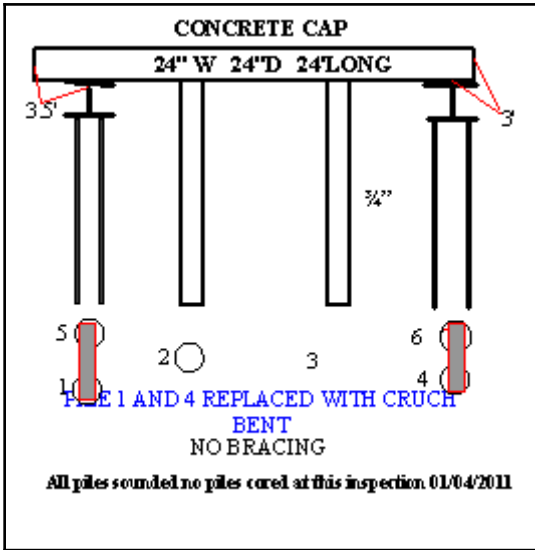
<u>Pile</u>	<u>Cir</u>	<u>Core Loc</u>	<u>Depth</u>	<u>Pent</u>	<u>Unbrace</u>	<u>Condition</u>	<u>Length</u>	<u>Spacing</u>
1	31.00	1'10" BELOW CAP	4.50	0.50	3.30	FAIR	3.30	6.00
2	36.00	2'8" BELOW CAP	4.20	0.25	4.40	FAIR	4.40	6.70
3	39.00	3'6" BELOW CAP	4.50	0.75	4.40	FAIR/SOFT	4.40	6.50
4	31.00		0.00	0.00	3.60	FAIR	3.60	0.00
5	31.00	1'7" BELOW CAP	4.00	0.25	3.30	FAIR	3.30	4.00
6	31.00		0.00	0.00	3.60	FAIR	3.60	4.00

CONCRETE CAP  
 CRUTCH BENTS REPLACING PILES 1 AND 4, WITH , 2 PILE CRUTCH AND 6' STEEL H PILE AS CAP  
 All piles sounded no piles cored at this inspection 01/04/2011
